**ALLHALLOWS MSCP  
BEDFORD, England**

**European Parking Awards 2015**

**CATEGORY 2: RENOVATED PROJECTS**

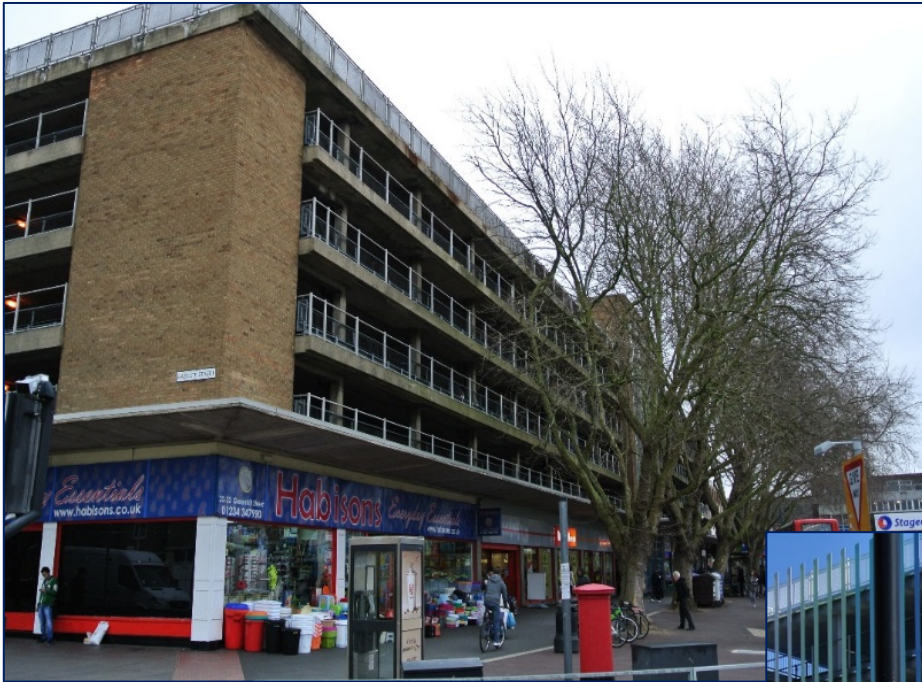
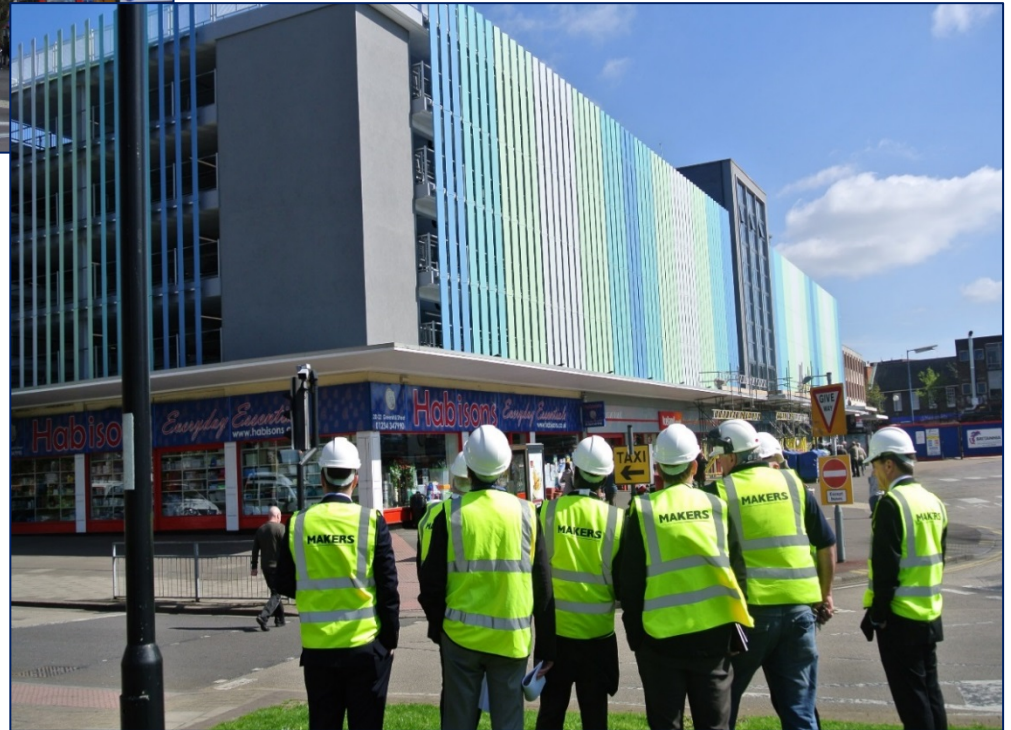
The drab & tired  
1960's exterior  
transforms in to ...

... a vibrant and  
modern parking  
structure fit for  
the 21<sup>st</sup> century.

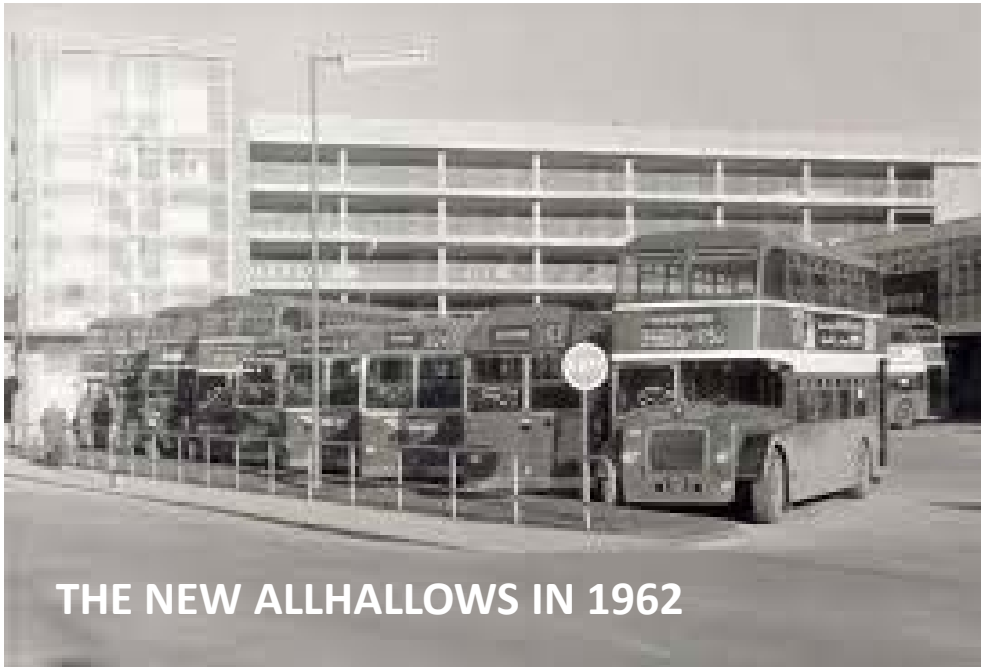
# The History of Allhallows, Bedford

The car park is an in-situ, flat slab reinforced concrete construction made up of 7 split-level suspended reinforced concrete decks with inclined ramps allowing circulation from one deck to another. Circular in-situ reinforced concrete columns support the decks.

External access ramps are also reinforced concrete.

Allhallows was constructed in two distinct periods: The first part (East) – including the main stair core – was constructed in 1960; the second part of the structure (West) was built c. 1962. Both parts of the structure are separated by a 25mm movement joint.

The structure is approximately 94m long by 32m wide with 600 parking spaces. The main access stairs & lifts are at the front of the car park facing on to the bus station. Access stairs are also located at the two rear corners of the building. The car park is built over the top of Retail Premises.

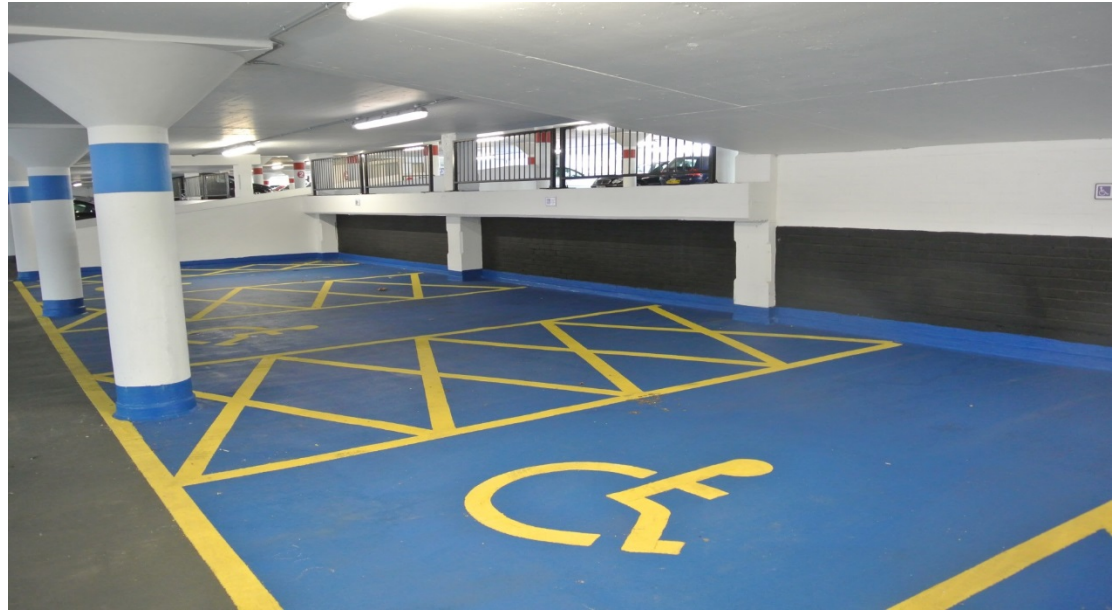
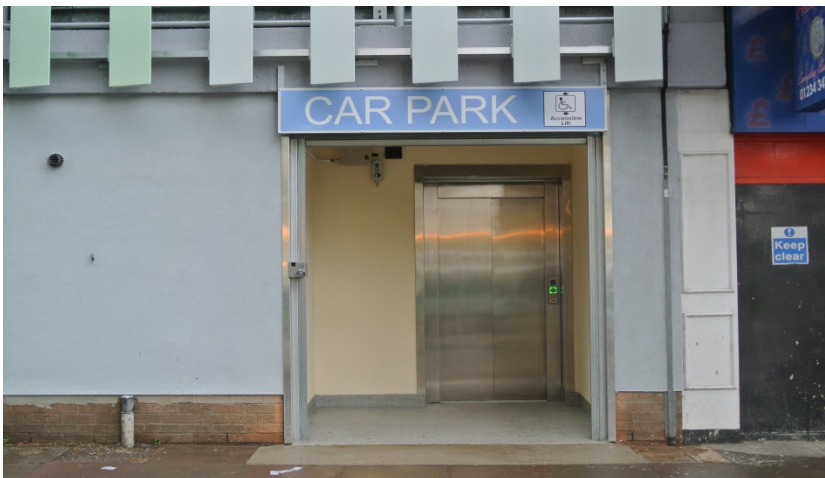
- New disabled parking area created on 1<sup>st</sup> floor (at top of a perpendicular ramp which is now used solely for disabled vehicles only. The area was chosen as it was a “dead” area in relation to traffic flow. Previous provision was on levels 2 and 4 next to the main stair core.

- A new dedicated disabled lift was created on the ground floor which travels up specifically to the first floor only and is solely dedicated to Disabled users. For additional security the lift is locked at night and protected with roller shutters.

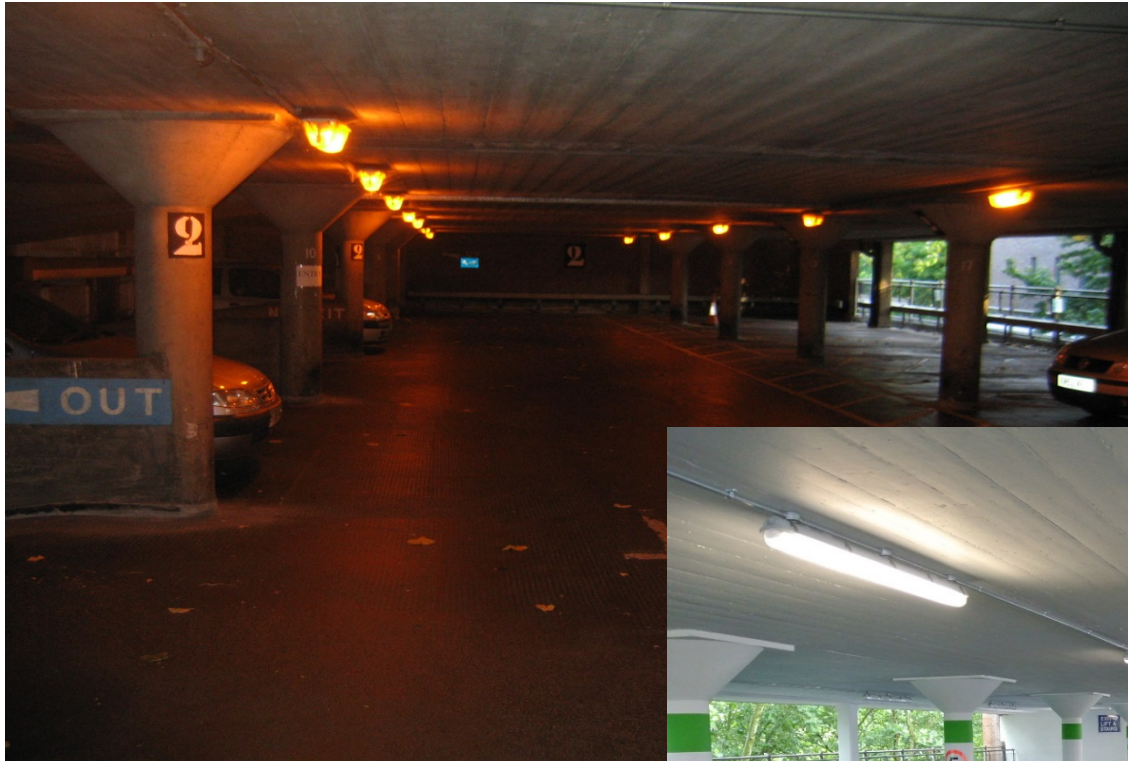
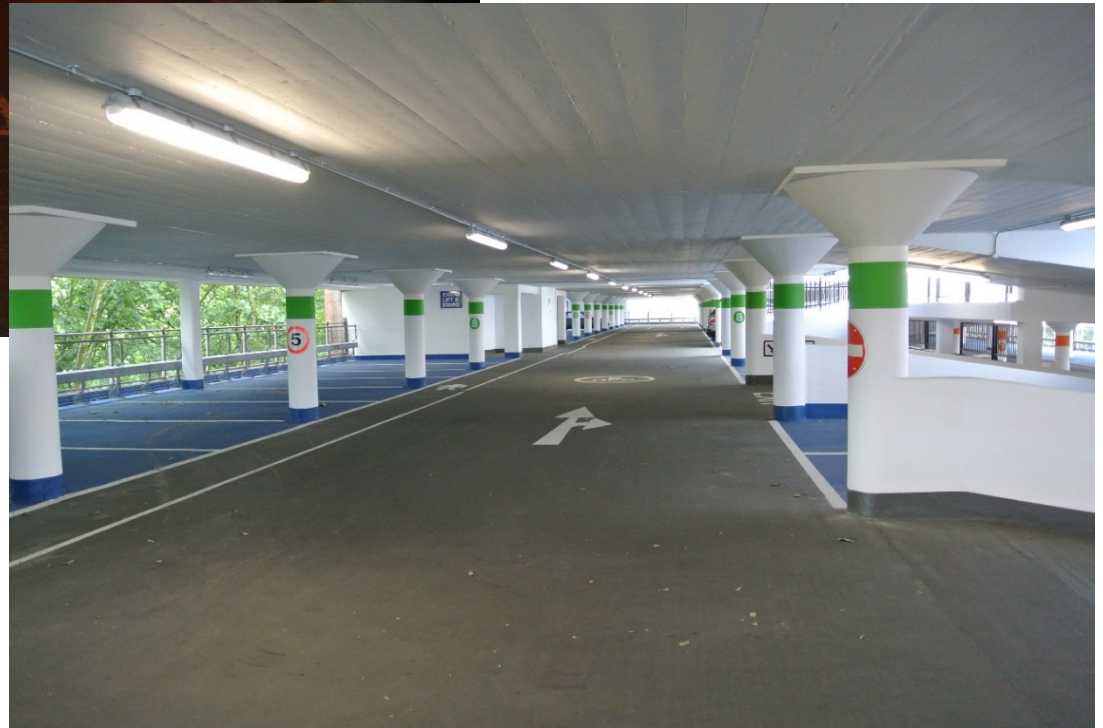
← Before

After →

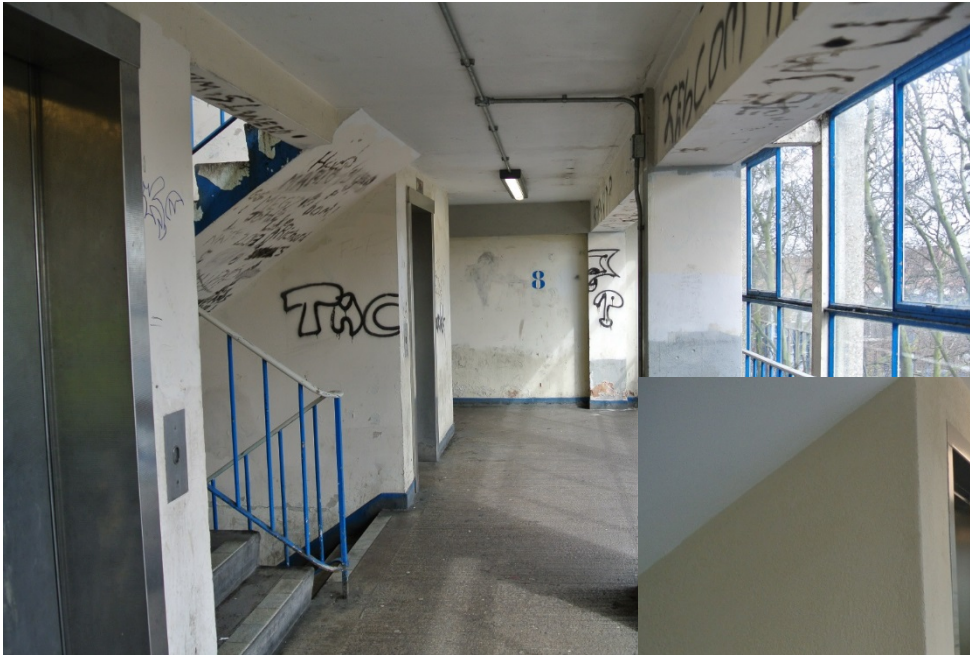
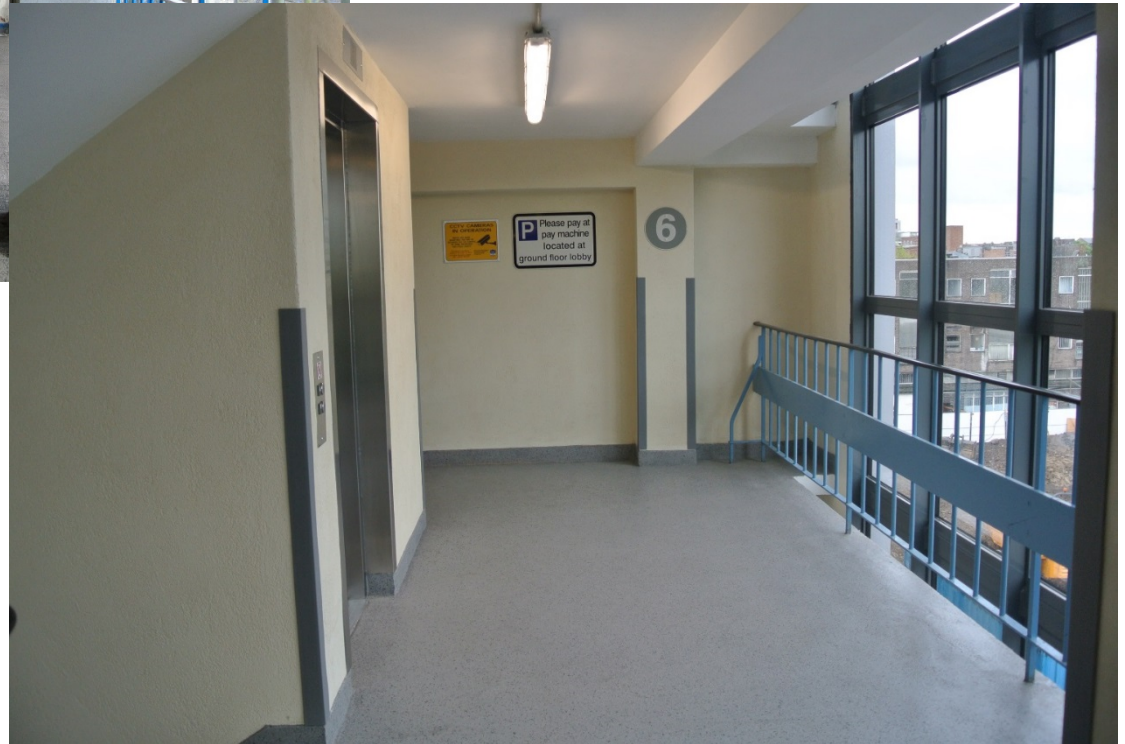
- Stairwells & Landings refurbished throughout to improve customer experience

- Decorated throughout
- New slip-resistant flooring to stairs & landings
- New & clear signage
- New lighting & CCTV
- New fenestration

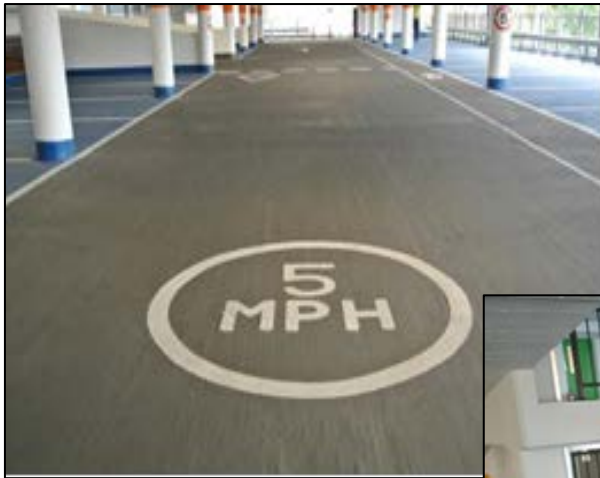
- P.I.R-activated lighting
- New, clear signage & instructions

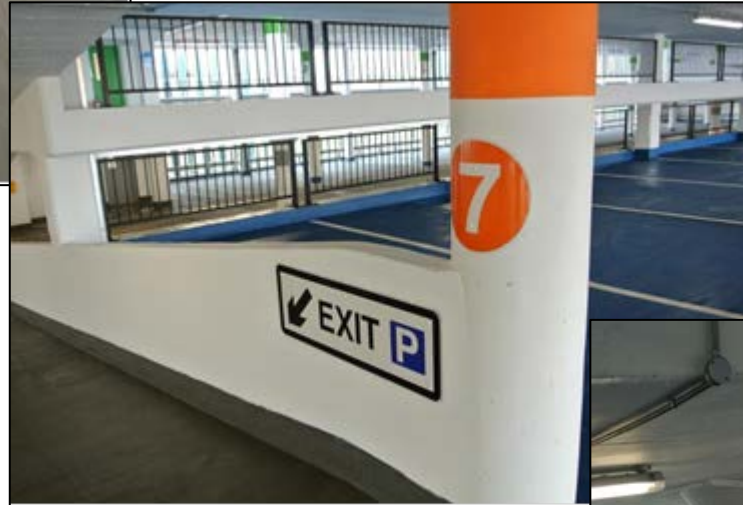
- Clearly defined drive & parking aisles with walkways have improved safety.

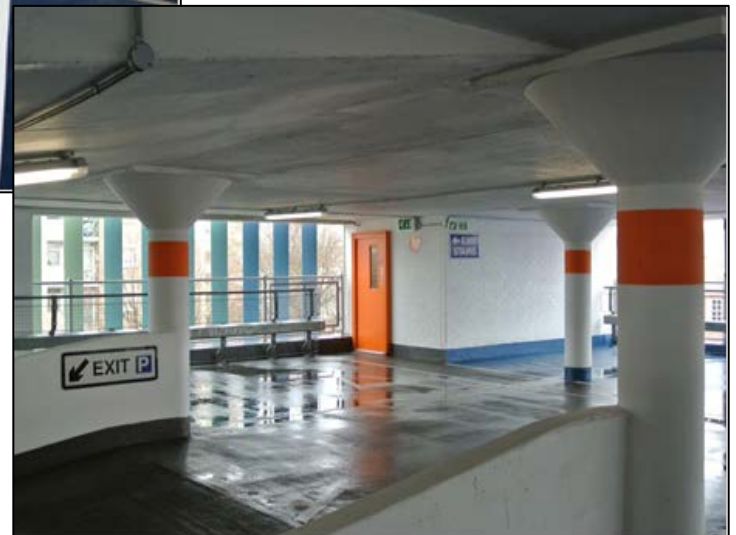
- Colour-coded levels with corresponding colour co-ordinated doors.

Two original circulation routes have now been simplified to one making the car park safer and easier to navigate with new signage.

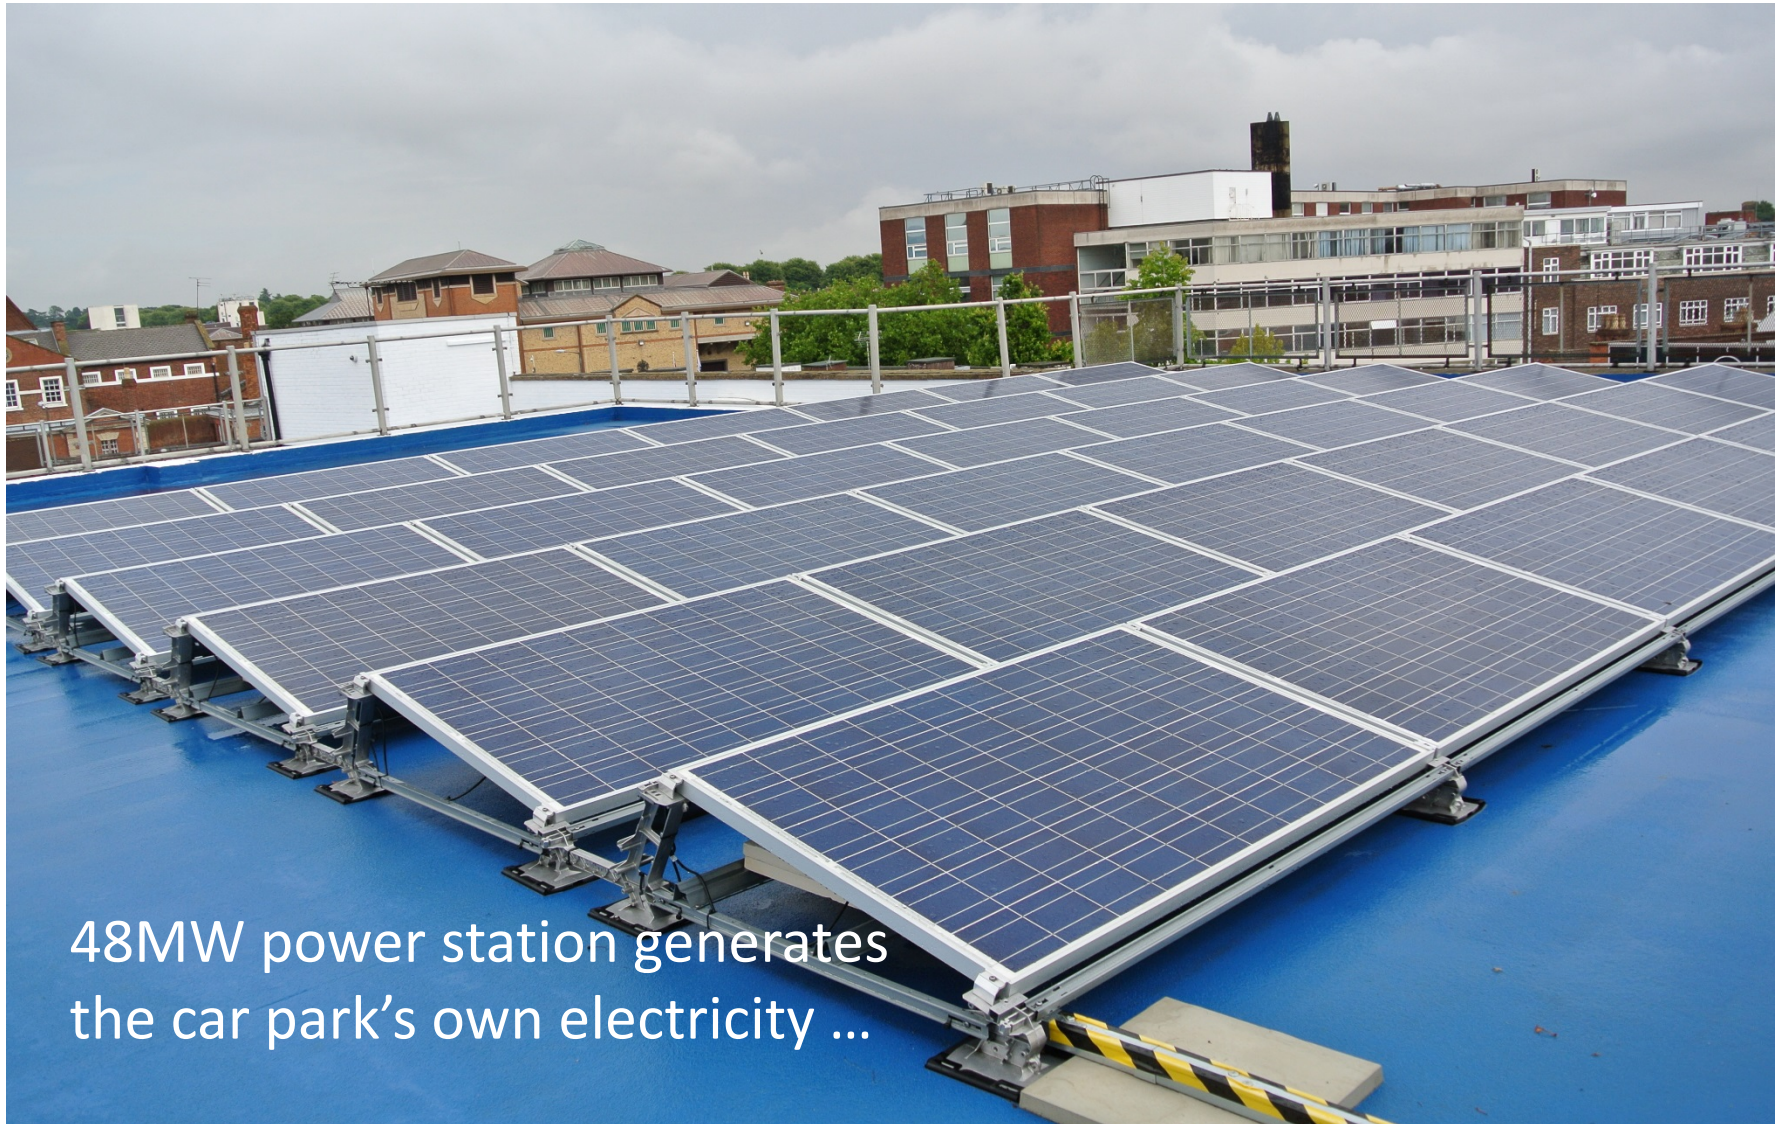
48MW power station generates  
the car park's own electricity ...
